National Dam Inspection Program.
Griffin Dam (NDI PA-035, PA455),
Susquehanna River Basin, West Beechwood
Run, Tioga County, Pennsylvania. Phase
I Inspection Report.

PA-455 Dam (Griffin Dam): NDS I.D. No. PA-00035

Owner: Tioga County Commissioners
State Located: Pennsylvania (PennDER I.D. No. 59-62)
County Located: Tioga County
Stream: West Beech Woods Run
Inspection Date(s): 6 & 7 November 1978
Inspection Team: GAI Consultants, Inc.
570 Beatty Road
Monroeville, Pennsylvania 15146

PHASE I INSPECTION REPORT
NATIONAL DAM INSPECTION PROGRAM
PA-455 DAM (GRIFFIN DAM)
NDI# PA-035, PENNDER# 59-62

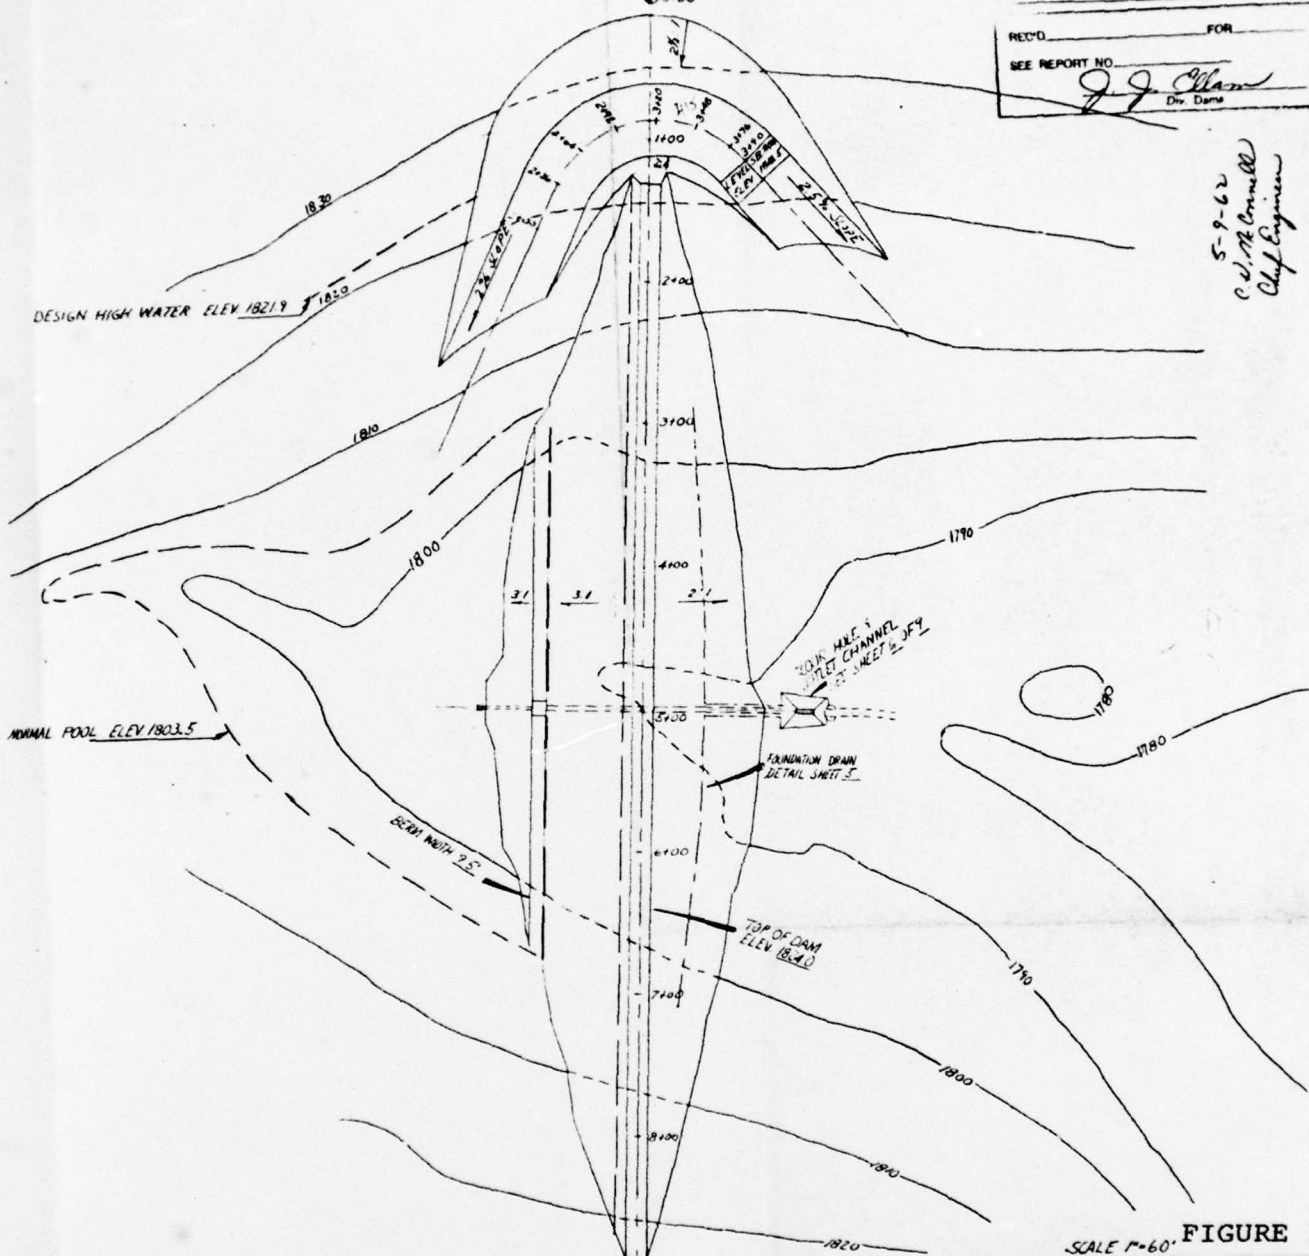
FIGURE 3

b) Emergency Spillway. The emergency spillway is a trapezoidal channel cut into natural ground on the left abutment. The control section measures 50 feet in length and is 20 feet wide. Available drawings indicate that the crest is set at elevation 1818.5 (see Figure 3).

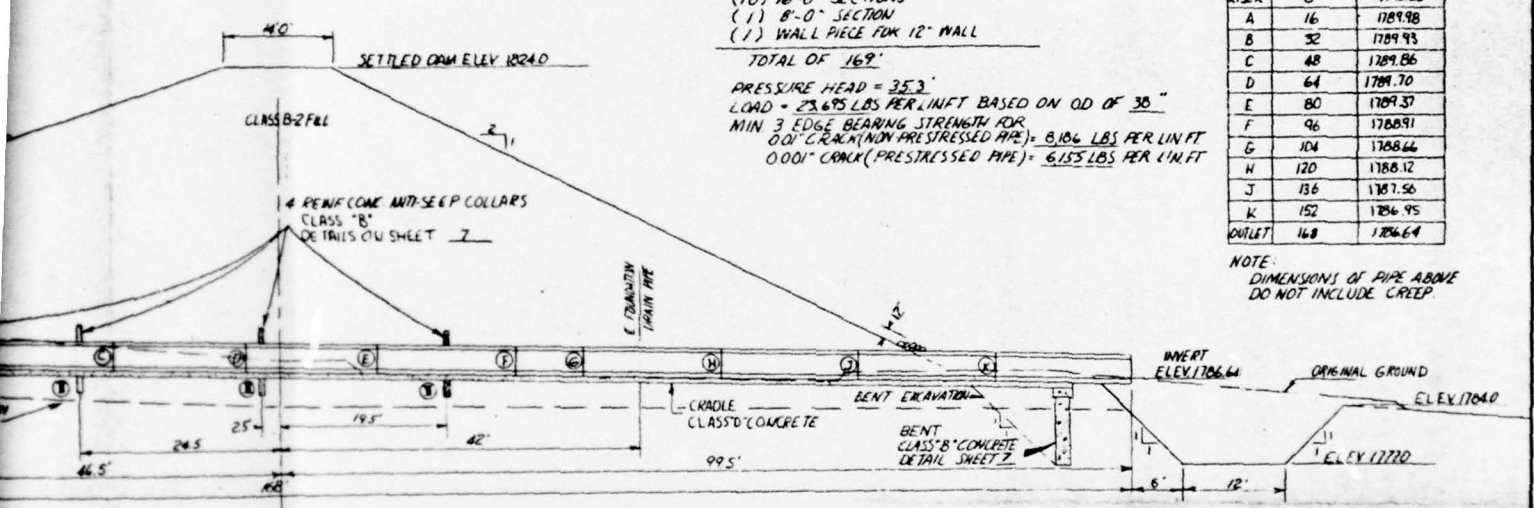
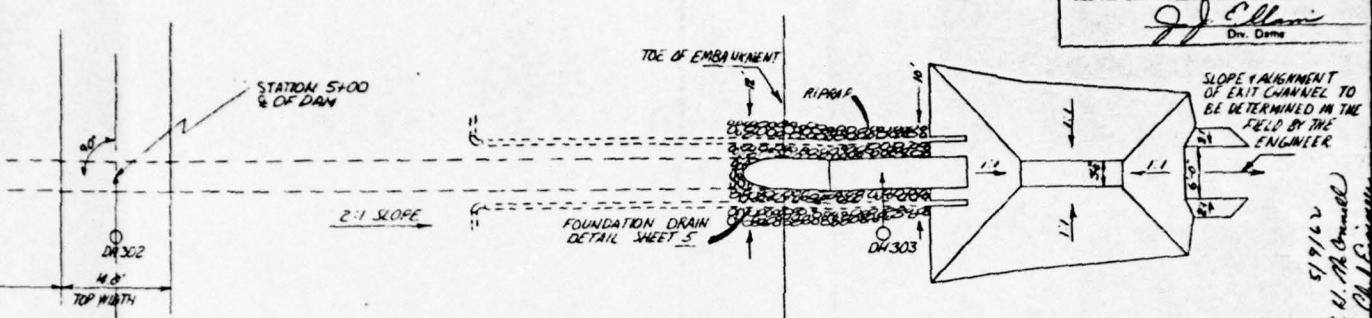
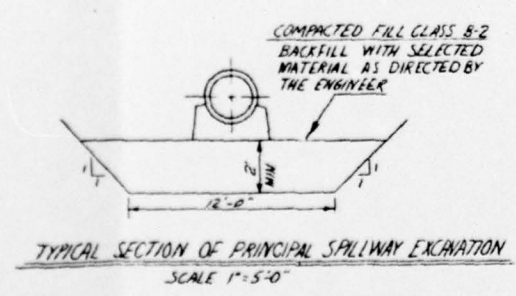
FIGURE 6

concrete riser and a 30-inch diameter, reinforced concrete, discharge conduit. The riser is a 25-foot high structure and is located along the upstream toe between Stations 4+00 and 5+00. The intake orifice (first stage opening) is set at elevation 1803.5 and is two feet wide by one foot high. The second stage overflow crest is set at elevation 1812.0 and consists of 7.5 feet of crest length on both sides of the riser (see Figures 6 and 7).
